STREAM BANK EROSION AS A SOURCE OF POLLUTION: RESEARCH REPORT

August 2005

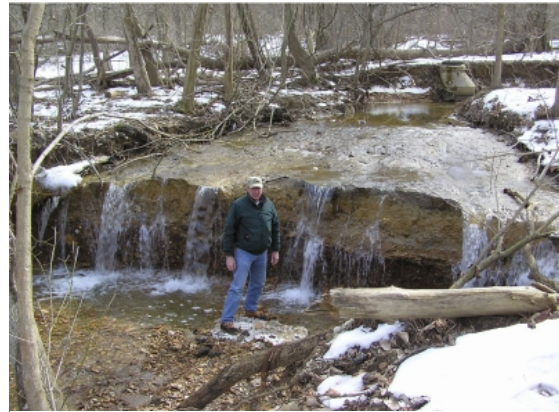
Legacy sediments in the Valley Creek Watershed, Chester County.

The origin of the problem in many areas apparently stems in part from the history of land use, in particular, massive land clearing and the location of mill dams by the thousands that dotted the landscape within the Chesapeake Bay watershed during the 18th and 19th centuries.

Franklin & Marshall College in Lancaster has documented many of the impacts of these old mills can have. Sediment from land clearing and poor agricultural practices accumulated behind the mills dams from just a few feet thick to more than 20 feet thick on top of the original floodplains.

As dams were removed or fell into disrepair, the streams began cutting down through the sediments and carrying those sediments downstream.
